Westmoreland County Shoreline Management Plan

***Prepared for
Westmoreland County and
Virginia Coastal Zone
Management Program***

Virginia Institute of Marine Science
College of William & Mary
Gloucester Point, Virginia

February 2013

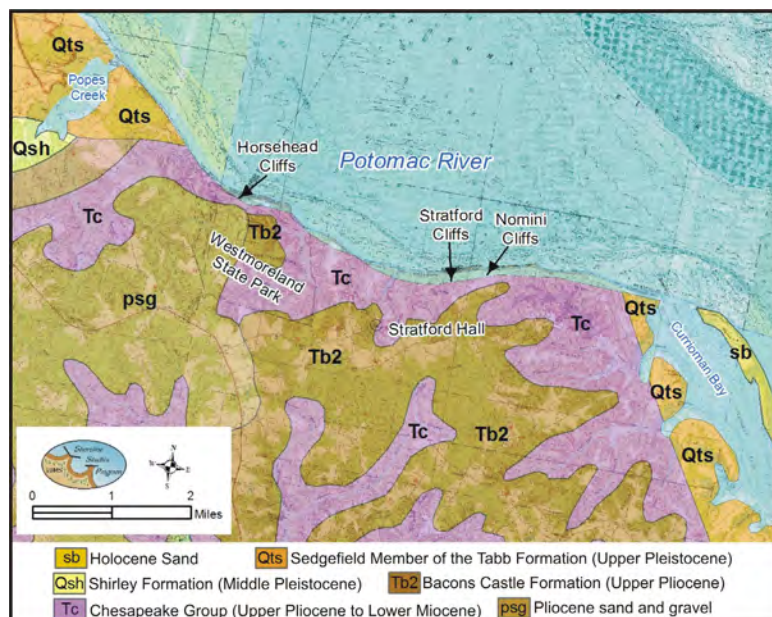
Figure 2-2. Geology of the Central Reach (Mixon *et al.*, 1989) overlain on a USGS topographic map. The complete description of the geologic formations is shown in Appendix 4.

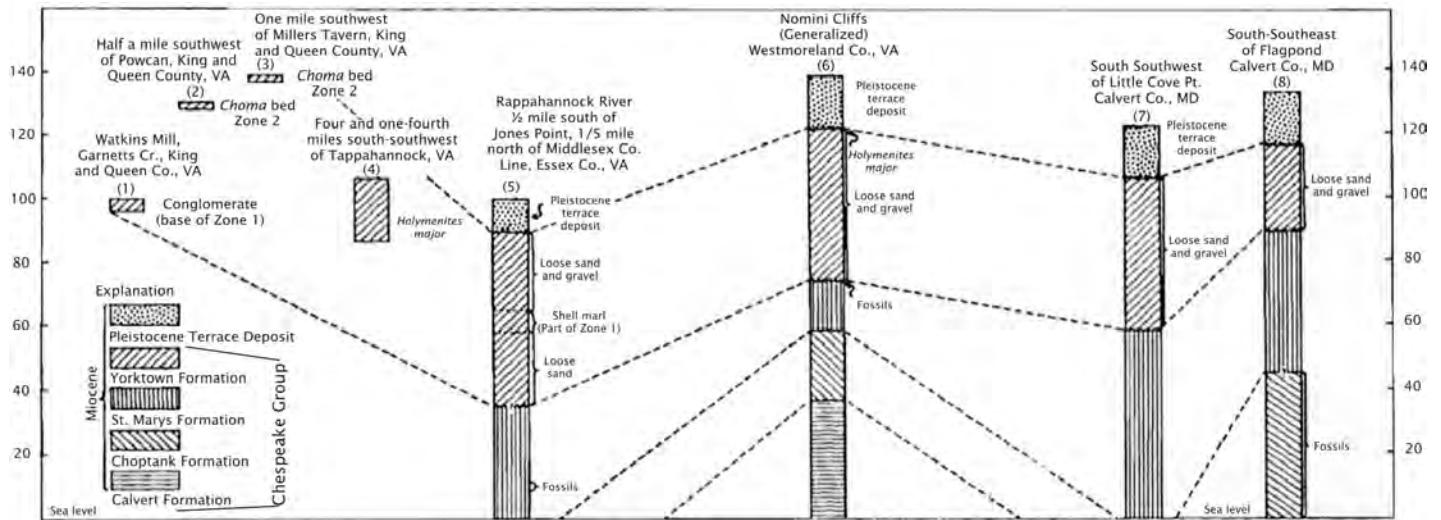
Figure 2-3. Stratigraphic section of Nomini Cliffs in Westmoreland County (from Stephenson and MacNeil, 1954).

A typical stratigraphic section of Central Reach at Westmoreland State Park and Stratford Hall Plantation (Figure 2-3) is shown in relation to similar outcrops on the Rap-

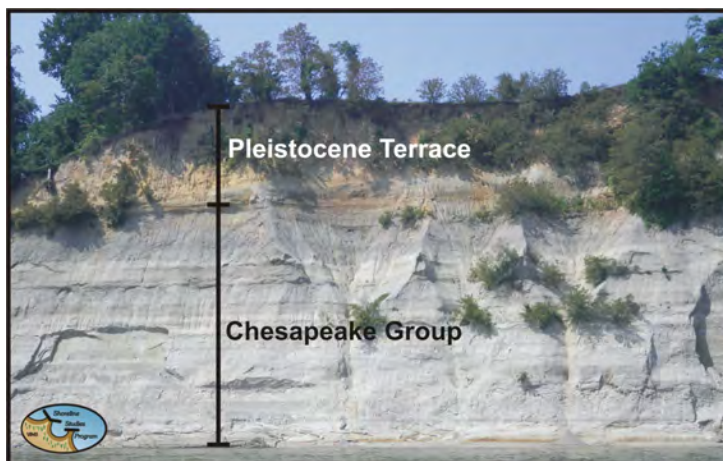
Figure 2-4. Nomini Cliffs along the Potomac River and their exposed strata.

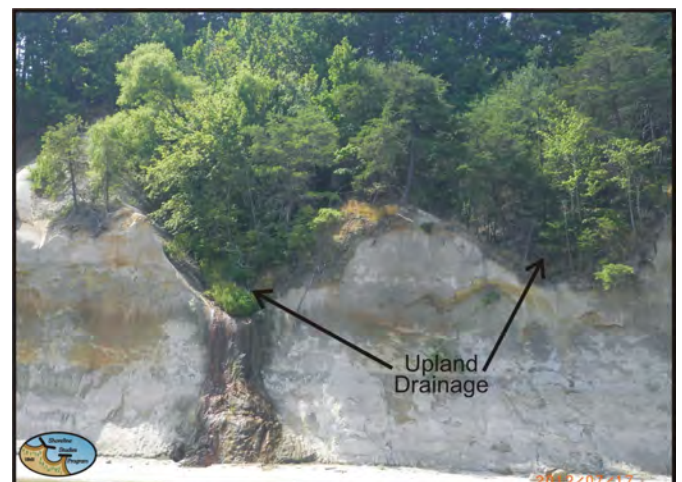
Figure 2-5. The cliffs along Westmoreland County have ancient upland drainages through which overland flow and groundwater enter the River.

No tidal creeks enter the Potomac River along the high bluff coast of Central Reach. The geology shows truncated ancient upland drainages (Figure 2-5). Bank heights along the shorelines, both on the Potomac and up the tidal creeks, rise quickly at the stratigraphic transition from 10 to 20 feet to over 80 feet creating obvious implications for shoreline management.

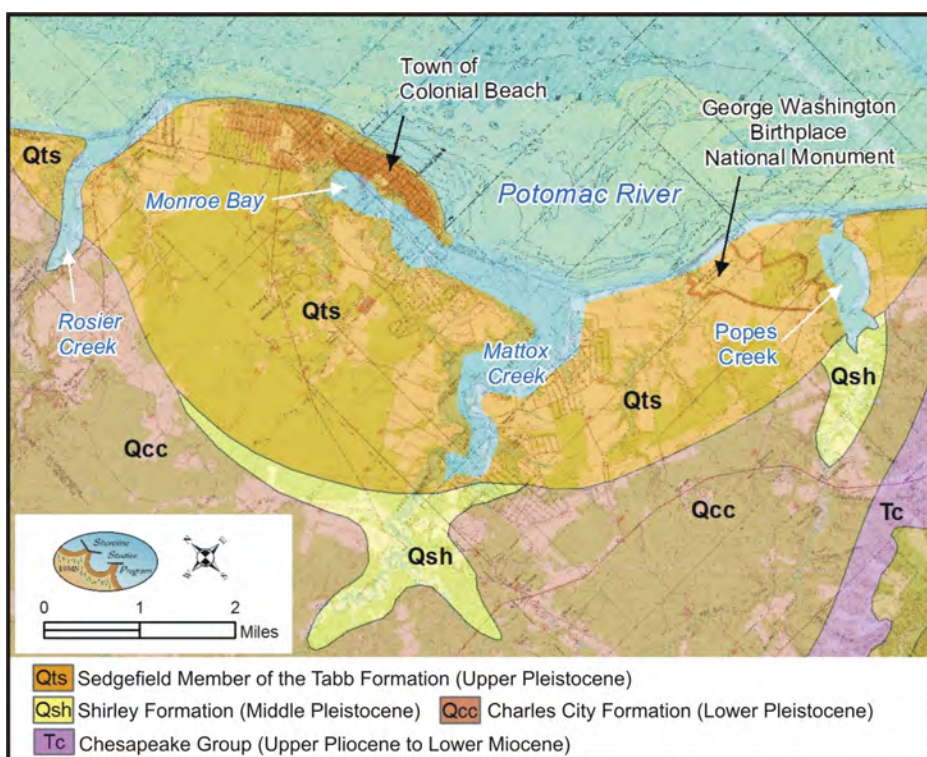
Figure 2-6. *Geology of the Upriver Reach (Mixon et al., 1989) overlain on a USGS topographic map. The complete description of the geologic formations is shown in Appendix 4.*

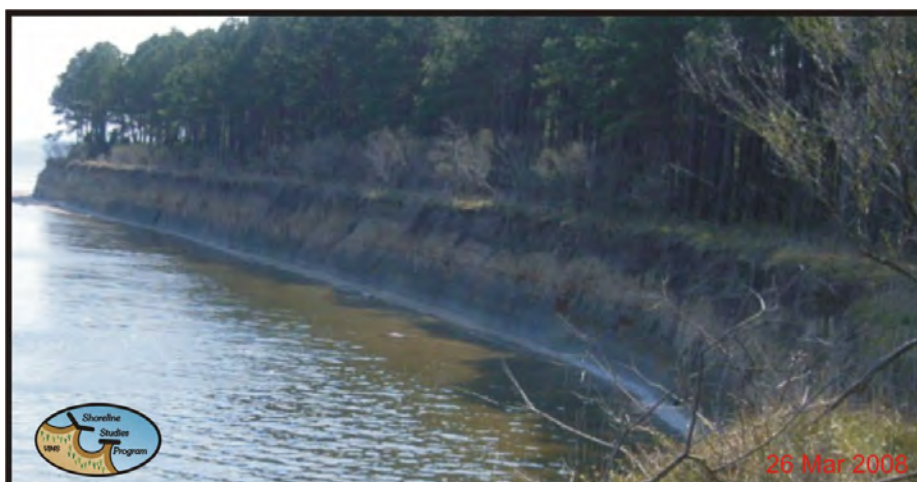
Figure 2-7. *Exposed Pleistocene strata along the George Washington Birthplace National Monument.*

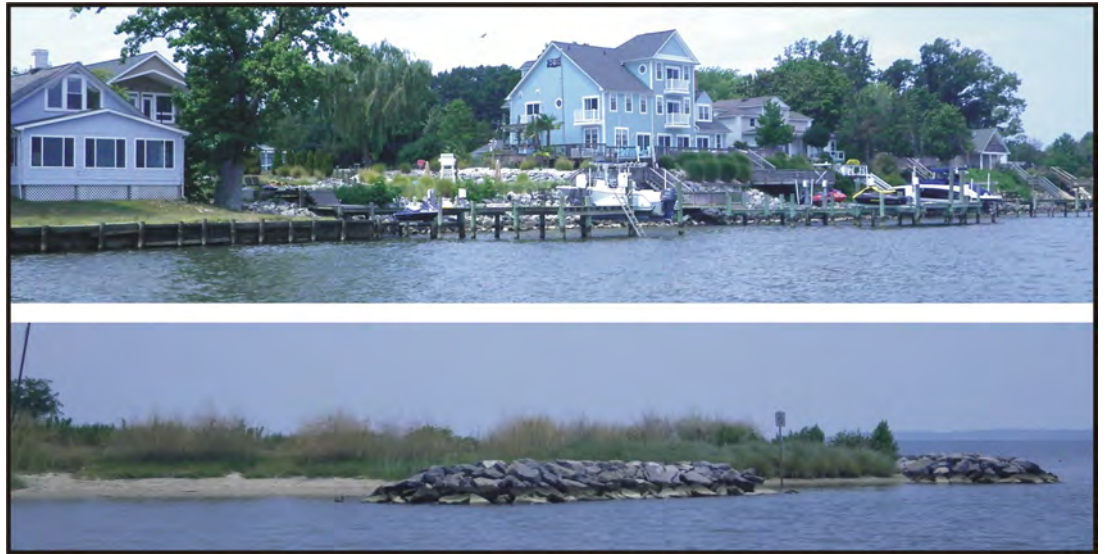
Figure 2-8. Modified shoreline of the Upriver Reach. Top: Bulkheads and revetments protect houses built close to the shoreline. Bottom: A breakwater system with beach and vegetation at the southern end of the Town of Colonial Beach.

ments and the breakwater systems along the Town of Colonial Beach (Figure 2-8).

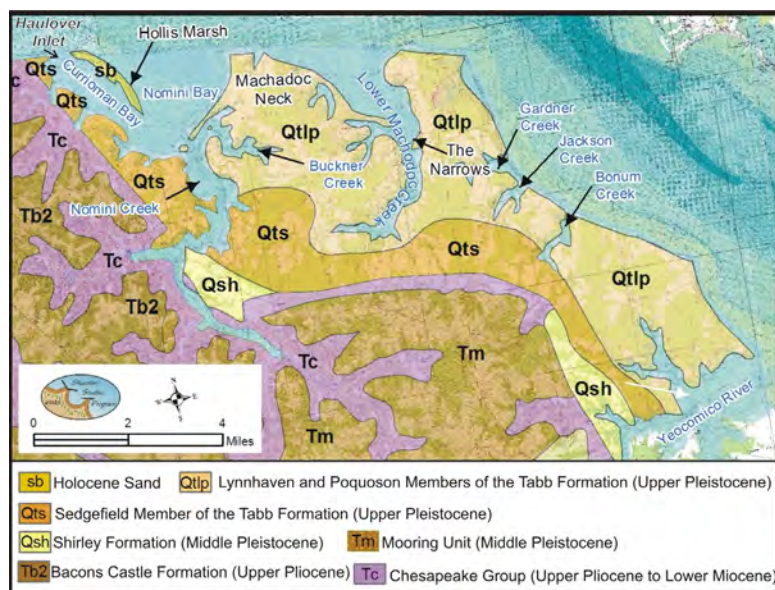
Figure 2-9. Geology of the Downriver Reach (Mixon et al., 1989) overlain on a USGS topographic map. The complete description of the geologic formations is shown in Appendix 4.

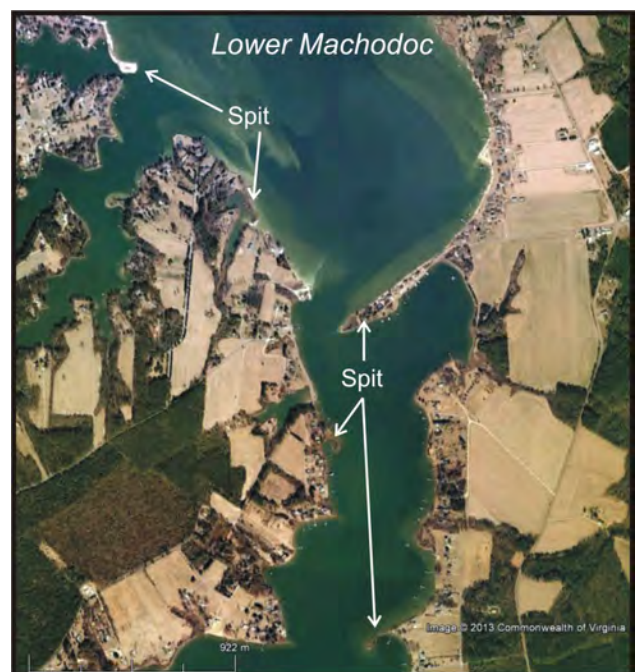
Figure 2-10. Location of spits in Lower Machodoc Creek.

numerous smaller contiguous creeks (Figure 2-9). The Potomac River shore banks are 15 to 20 feet in height and consist of exposures of the Lynnhaven and Poquoson Members of the Tabb Formation. Nomini Bay and Lower Machodoc Creek are separated by Machodoc Neck. Each of these tidal systems has a broad mouth and an embayment that narrows southward to a narrow creek that is defined by restrictive spit features. These depositional features are sediment sinks, derived from erosion of the updrift banks (Figure 2-10)

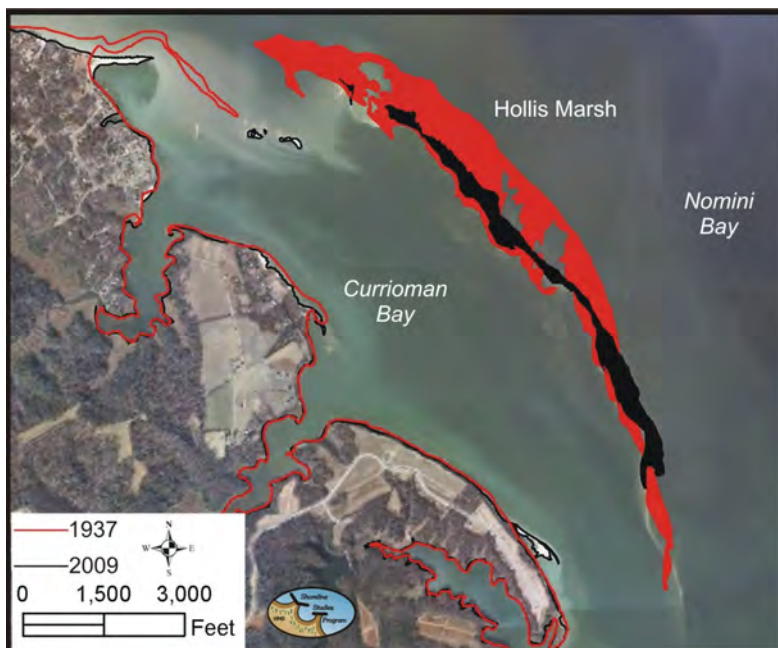
Figure 2-11. The deterioration of Hollis Marsh between 1937 and 2009.

Of note is the Hollis Marsh spit which at one time extended across and down the coast to create Currioman Bay (Figure 2-11). With time, this feature has detached from the mainland and steadily decreased in size to its present configuration. Other notable geomorphic features include the spit along the east side of

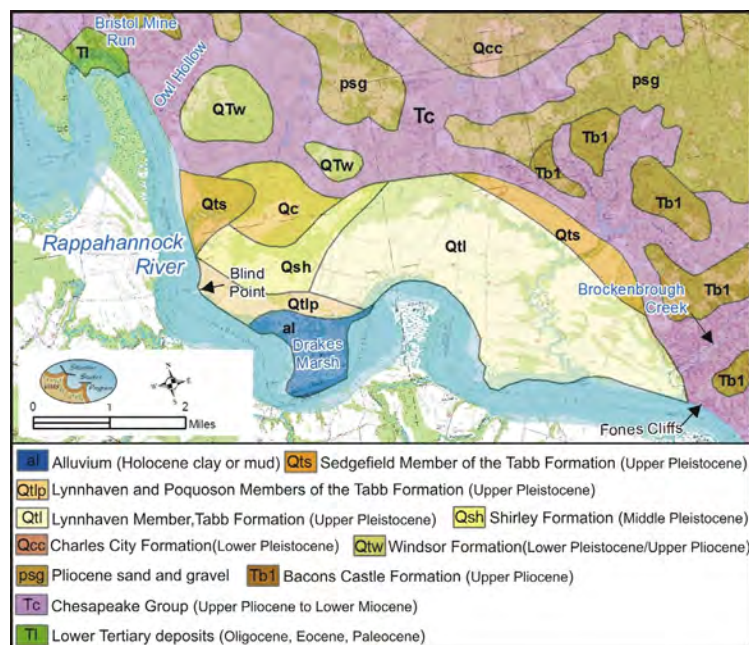
Figure 2-12. Geology of Westmoreland County's Rappahannock River shore zone (Mixon et al., 1989) overlain on a USGS topographic map. The complete description of the geologic formations is shown in Appendix 4.

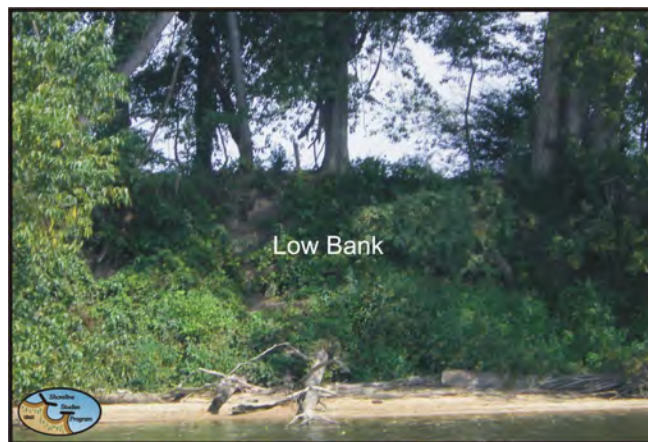
Figure 2-13. The low, Pleistocene upland banks along the Rappahannock River.

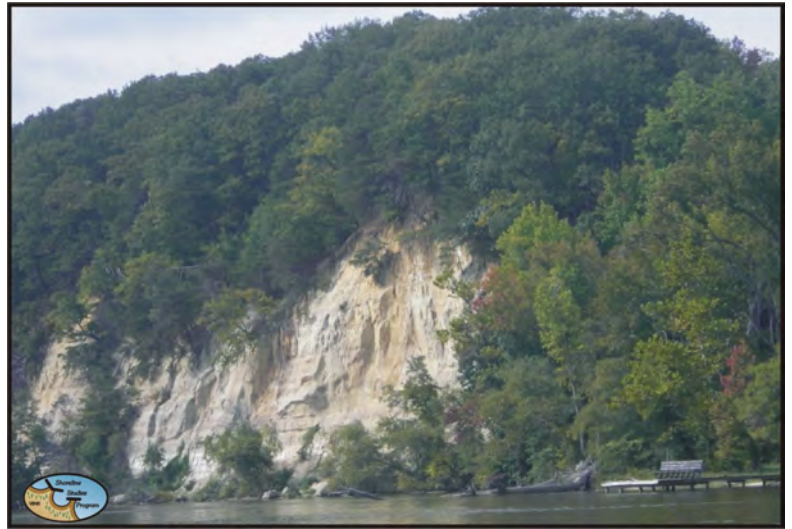
Figure 2-14. Cliffs along Westmoreland County's Rappahannock River shoreline.

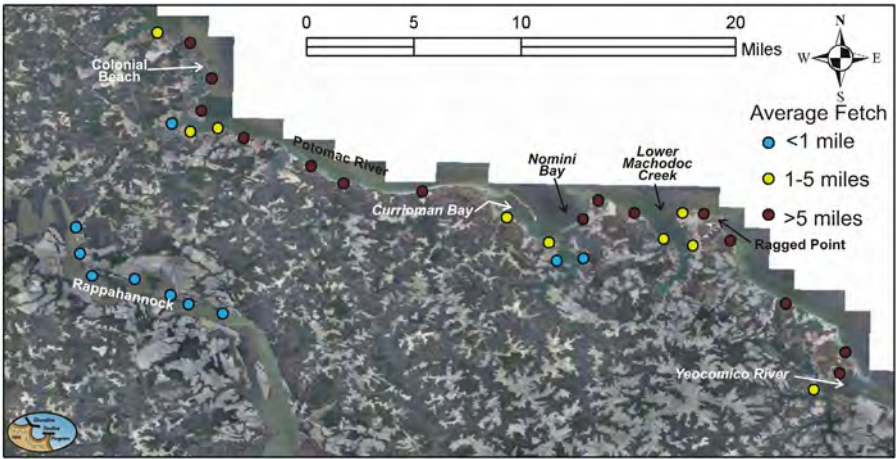
Figure 2-15. Average fetch exposures along Westmoreland County’s main shorelines.

All of the Potomac River shoreline in Westmoreland County that faces north and northeast is considered high-energy shoreline with fetches greater than 5 miles (Figure 2-15). Colonial Beach and the downriver shorelines of the Upriver Reach that face due east are exposed to a longer southeasterly component. The Central Reach faces about north-northeast along its northern section but turns to face north along the downriver portion of the reach. This turn exposes the waves to a northwestern wave condition in addition to the north and northeast. During northeast storm events, the winds typically shift from northeast, to

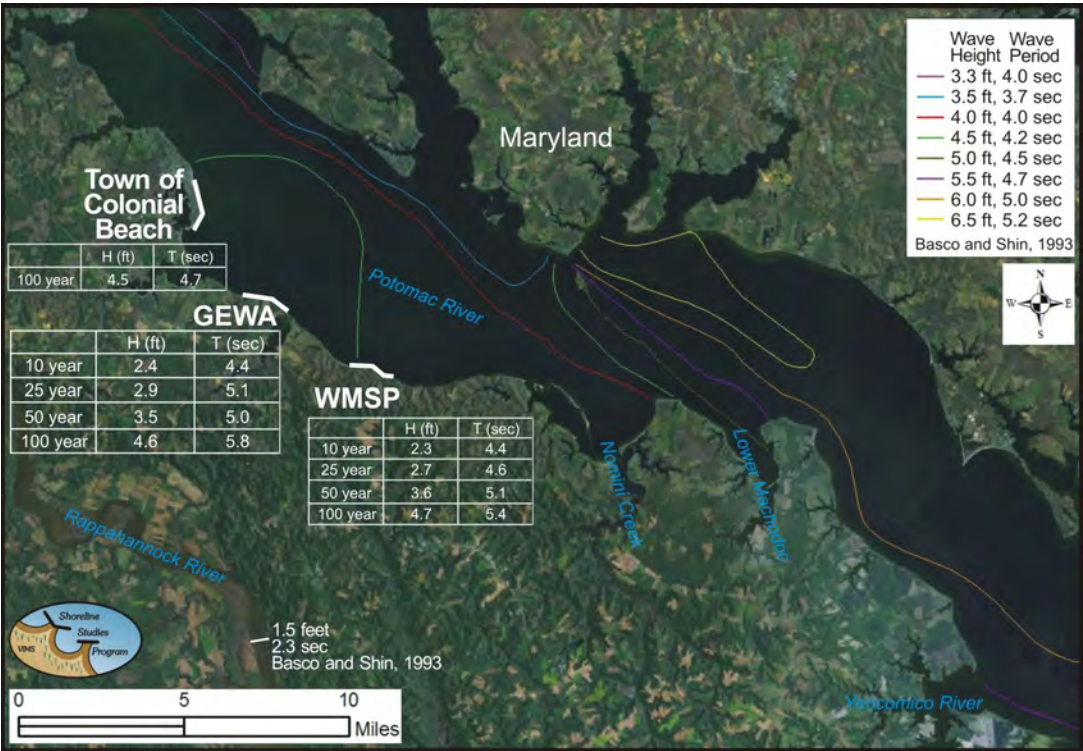
Figure 2-16. Wave heights along Potomac River summarized from Basco and Shin (1993), Milligan et al. (2002), Hardaway et al. (2009), and Hardaway and Milligan (2009).

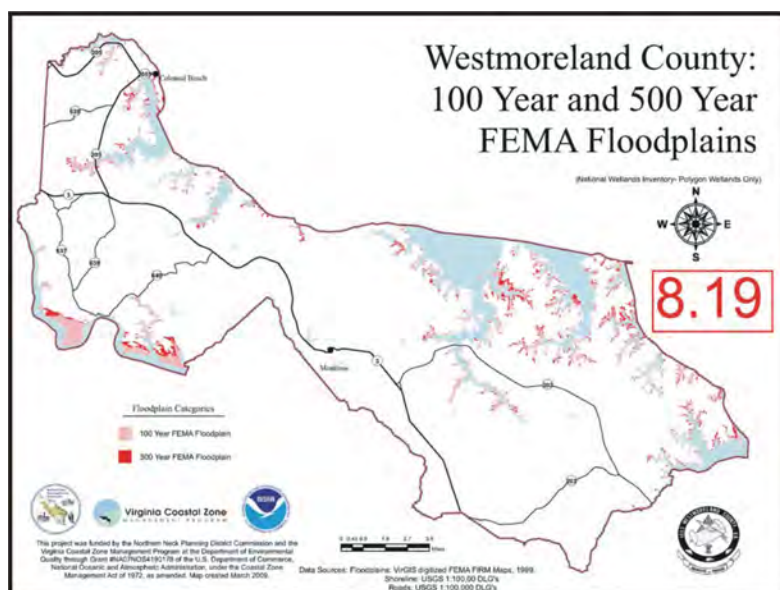
Figure 2-17. Map of the FEMA floodplains for the 100 year and 500 year events (Westmoreland County, 2010).

In Westmoreland County, the 100 year and 500 year storm events described by FEMA and found in the Westmoreland County Comprehensive Plan (2010) show the coastal regions that would be impacted (Figure 2-17). Most of the areas impacted are found along the tidal creek shorelines. Since the areas on the open Potomac River have higher banks, they do not flood. They are, however, exposed to higher wave energies during storms.

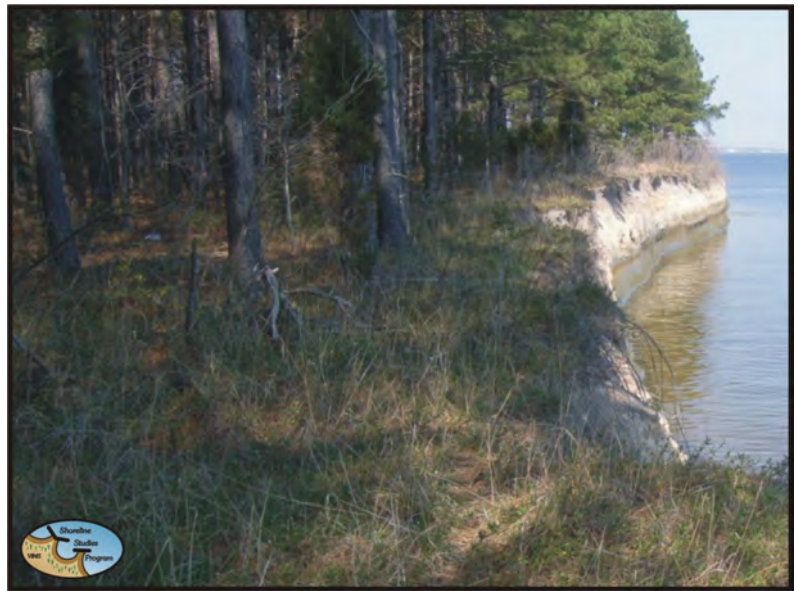
Figure 3-1. One example of forest management in Westmoreland County. The edge of the bank is kept free of tree and shrub growth to reduce bank loss from tree fall.

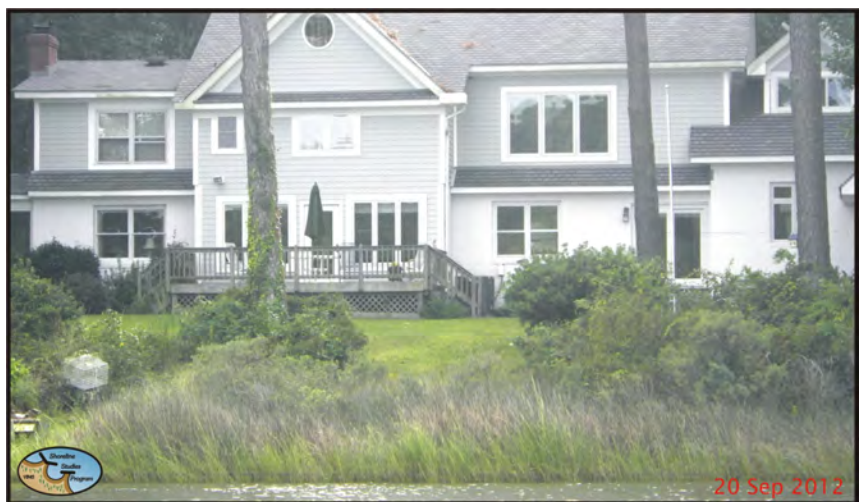
Figure 3-2. Maintaining and enhancing the riparian and marsh buffers can maintain a stable coastal slope.

Enhancement of both riparian and existing marsh buffers together can be an effective practice to stabilize the coastal slope (Figure 3-2) from the intertidal area to the upland by allowing plants to occupy suitable elevations in dynamic fashion to respond to seasonal fluctuations, shifts in precipitation or gradual storm recovery. At the upland end of the slope, forest buffer restoration and the planting of ornamental grasses, native shrubs and small trees is recommended. Enhancement of the marsh could include marsh plantings, the use of sand fill necessary to plant marsh vegetation, and/or the need for fiber logs to stabilize the bank toe and newly established marsh vegetation.

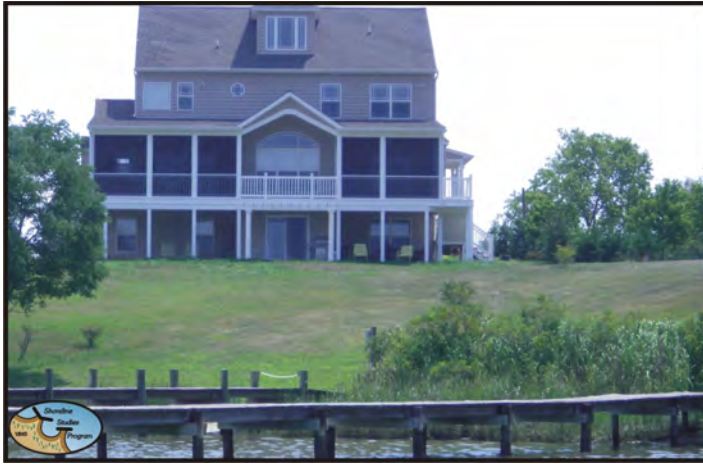
Figure 3-3. Bank grading in Westmoreland County reduces steepness and improves growing conditions for vegetation stabilization.

In cases where the bank is unstable, medium or high in elevation, and very steep, bank grading may be necessary to reduce the steepness of bank slopes for wave run-up and to improve growing conditions for vegetation stabilization (Figure 3-3). The ability to grade a bank may be limited by upland structures, existing defense structures, adjacent property conditions, and/or dense vegetation providing desirable ecosystem services.

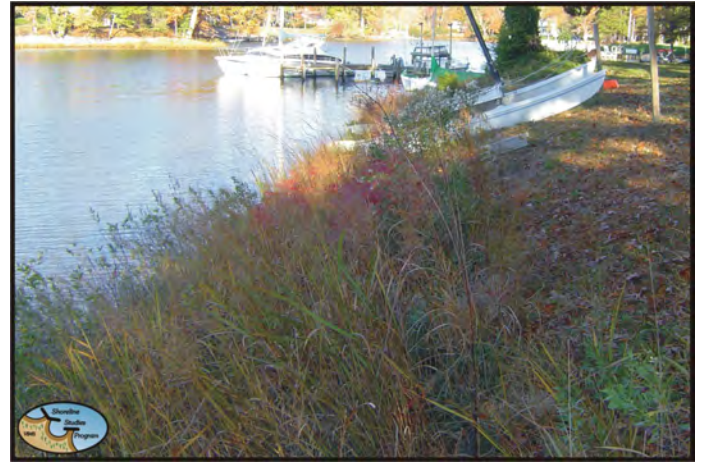
Figure 3-4. This low-energy site had minor bank grading and *Spartina alterniflora* planted. This photo shows the site after 24 years.

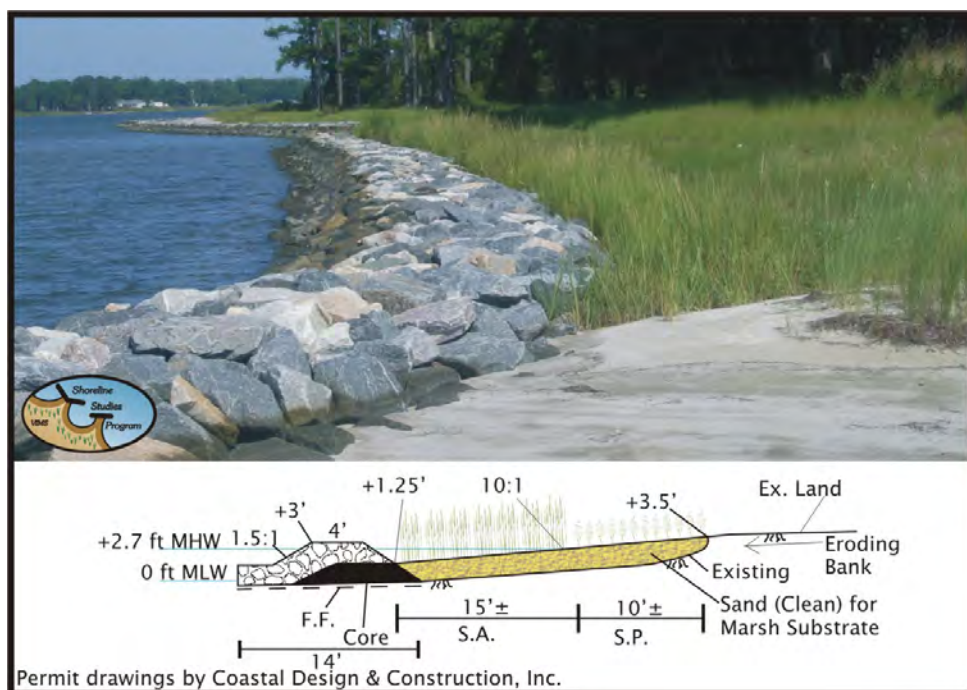
Figure 3-5. Sand fill with stone sills and marsh plantings at Poplar Grove, Mathews County, Virginia after six years and the cross-section used for construction (From Hardaway et al., 2010b).

The stone sill has been used extensively in the Chesapeake Bay over the years (Figure 3-5). It is a rock structure placed parallel to the shore so that a marsh can be planted behind it. The cross-section in Figure 3-5 shows the sand for the wetlands substrate on a slope approximating 10:1 from the base of the bank to the back of the sill. The elevation of the intersection of the fill at the bank and tide range will determine, in part, the dimensions of the sill system. If the nearshore depth at the location of a sill is greater than 2 feet, it might be too expensive for a sill relative to a revetment at that location. Nevertheless, the preferred approach would still be the marsh sill.

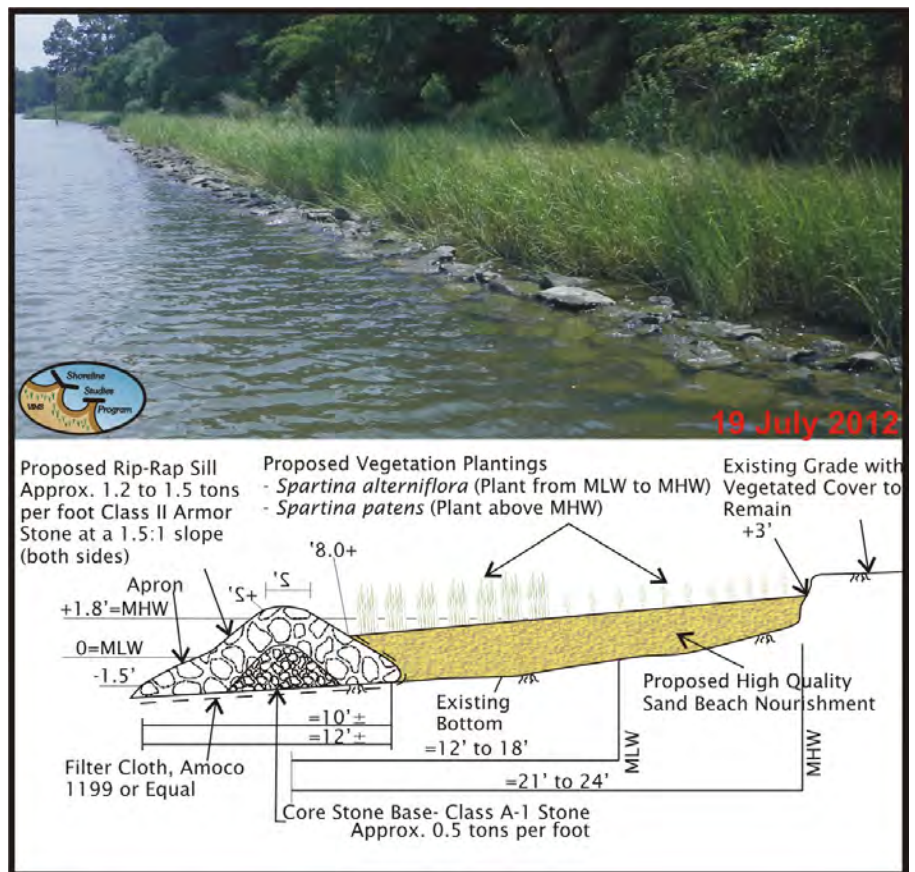
Figure 3-6. Longwood University's Hull Springs Farm four years after construction and the cross-section used for construction (from Hardaway et al., 2010a).

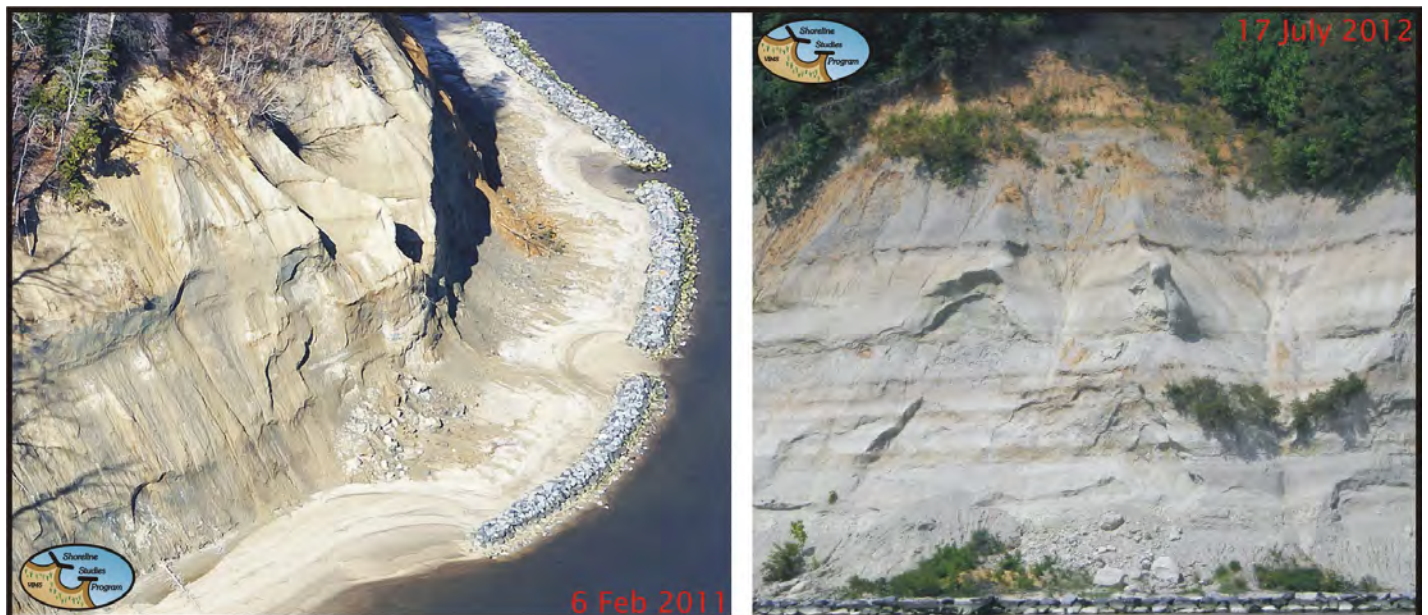
Figure 3-7. High sills built along Westmoreland State Park's high energy, high bank shoreline. The material that slumps from the bank will be caught behind the sills and stabilize the base of the bank by protecting it from wave attack. A more recent photo shows that the slump material is starting to become vegetated.

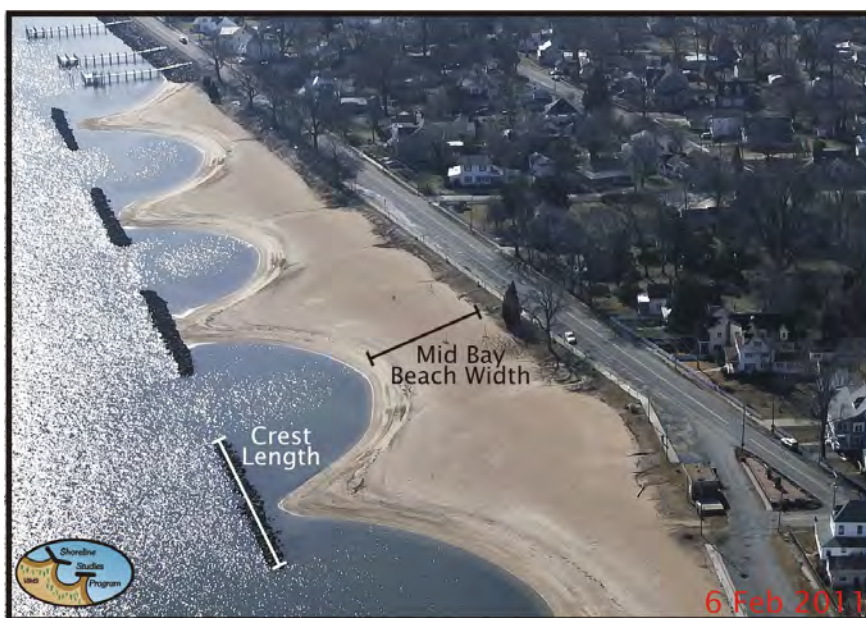
Figure 3-8. The breakwaters at Colonial Beach provide a wide recreational beach as well as storm erosion protection for the residential upland. These structures were installed in 1982.

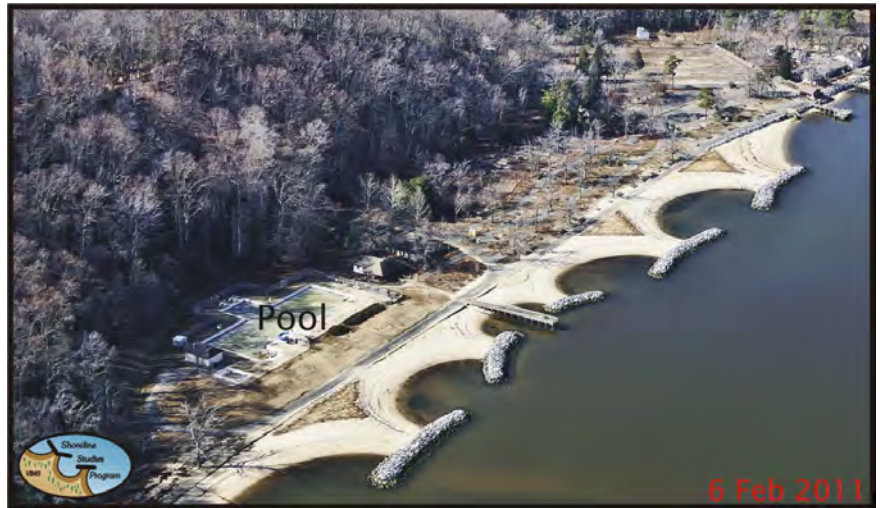
Figure 3-9. Headland attached breakwaters at Westmoreland State Park. These structures were built relatively closely-space to provide a recreational beach as well as to protect the infrastructure including the pool and bathhouses.

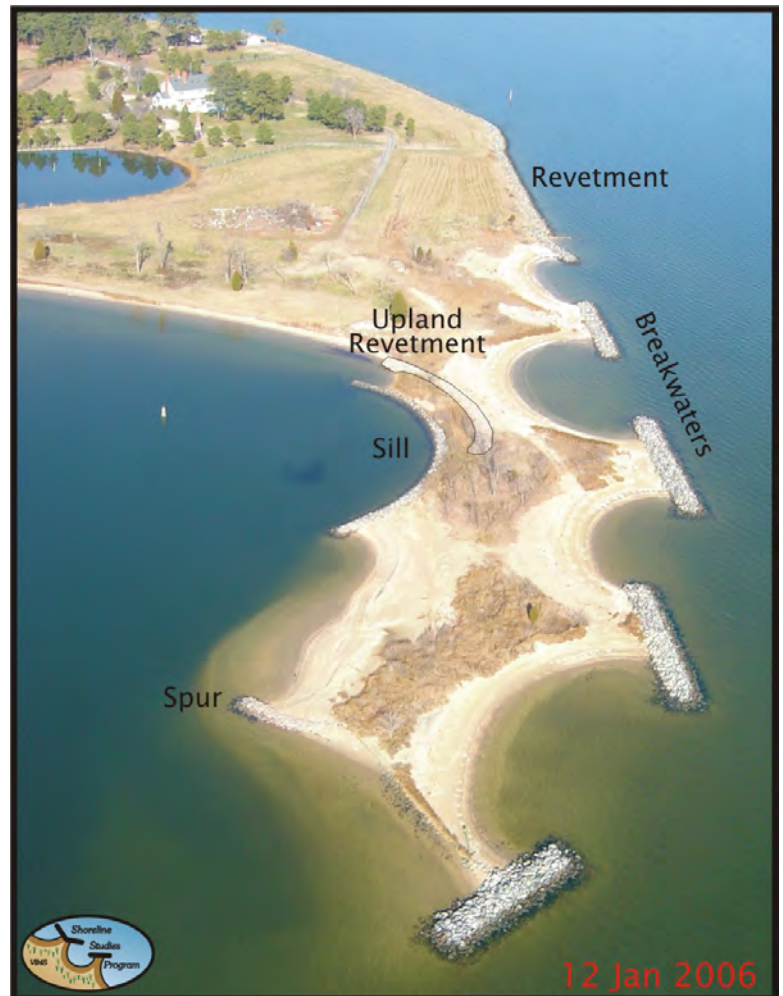
Figure 3-10. Headland attached breakwaters along the Potomac River at the Yeocomico River. The breakwaters hold a spit that protects the shoreline in its lee. A sill protects the back side of the spit. To protect breakthrough flooding, an upland revetment was built on the narrowest section of the spit.

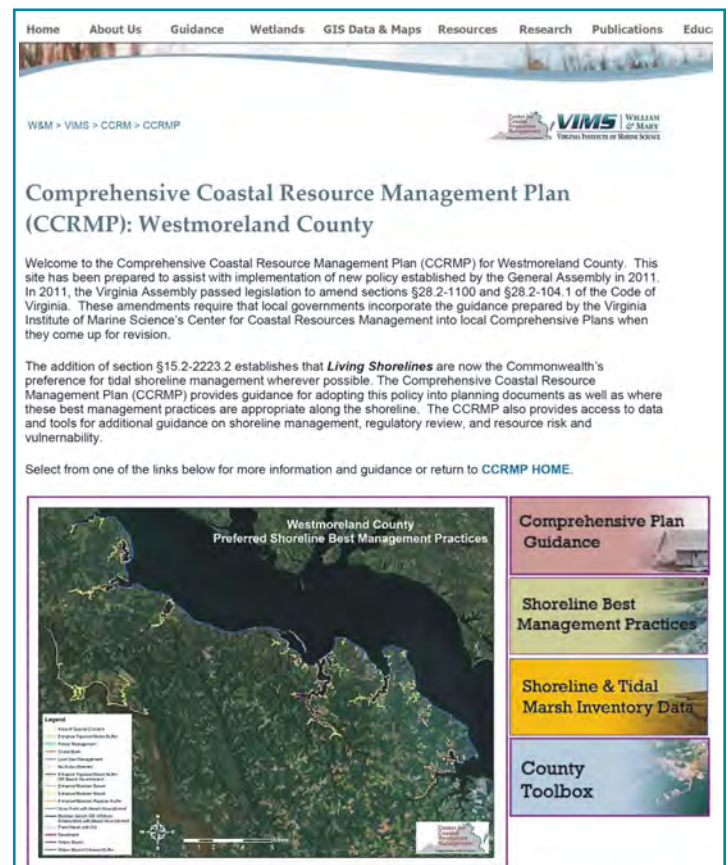
Figure 5-1. Portal for Comprehensive Coastal Resource Management in Westmoreland County.

To view the model output, the Center for Coastal Resources Management has developed a Comprehensive Coastal Resource Management portal (Figure 5-1) which includes a pdf file depicting the SMM output as well as an interactive map viewer that illustrates the SMM output as well as the baseline data for the model (<http://ccrm.vims.edu/ccrmp/westmoreland/index.html>).

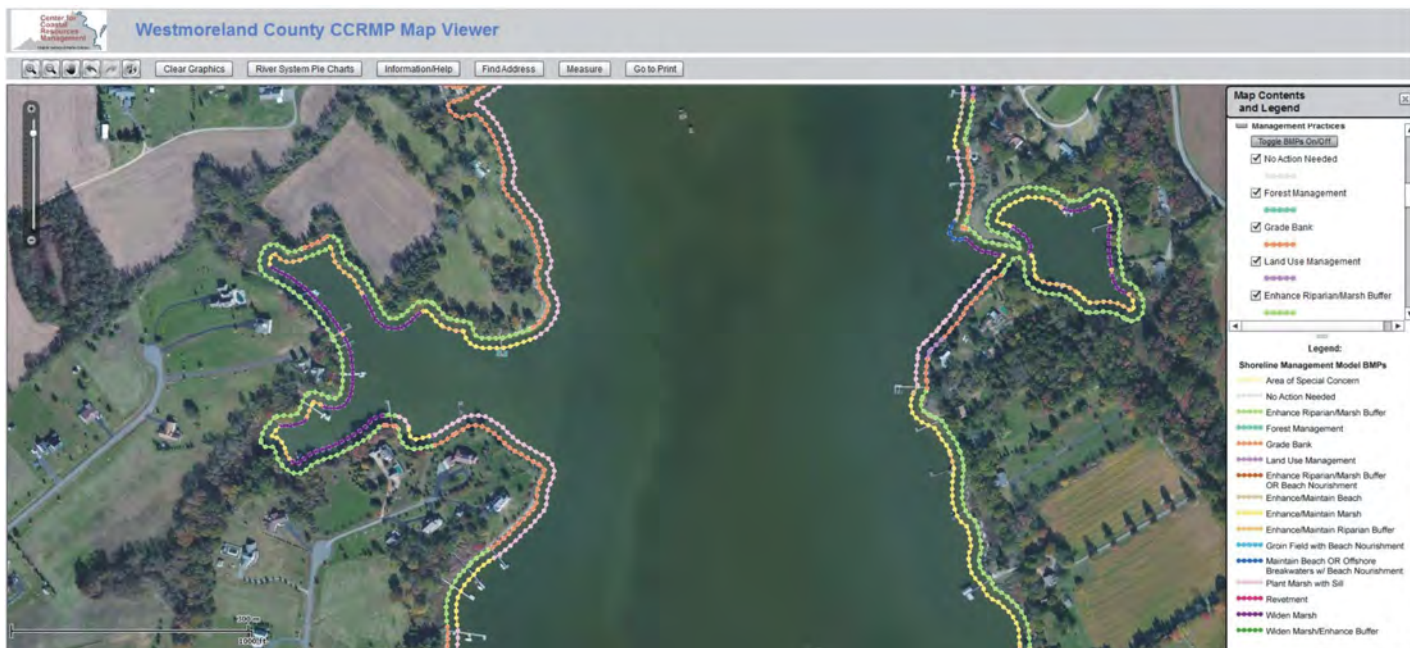
Figure 5-2. The Map Viewer displays the preferred Shoreline BMPs in the map window. The color-coded legend in the panel on the right identifies the treatment option recommended.

The pdf file is found under the tab for Shoreline Best Management Practices. The Map Viewer is found in the CountyToolbox and uses a Google type interface developed to enhance the end-users visualization (Figure 5-2). From the map viewer the user can zoom, pan, measure and cus-

tomize maps for printing. When “Shoreline Management Model BMPs” is selected from the list in the right hand panel and toggled “on” the delineation of shoreline BMPs is illustrated in the map viewing window. The clickable interface conveniently allows the user to click anywhere in the map window to receive specific information that pertains to conditions onsite and the recommended shoreline strategy. Figure 5-3 demonstrates a pop-up window displayed onscreen when a shoreline segment is clicked in the map window.

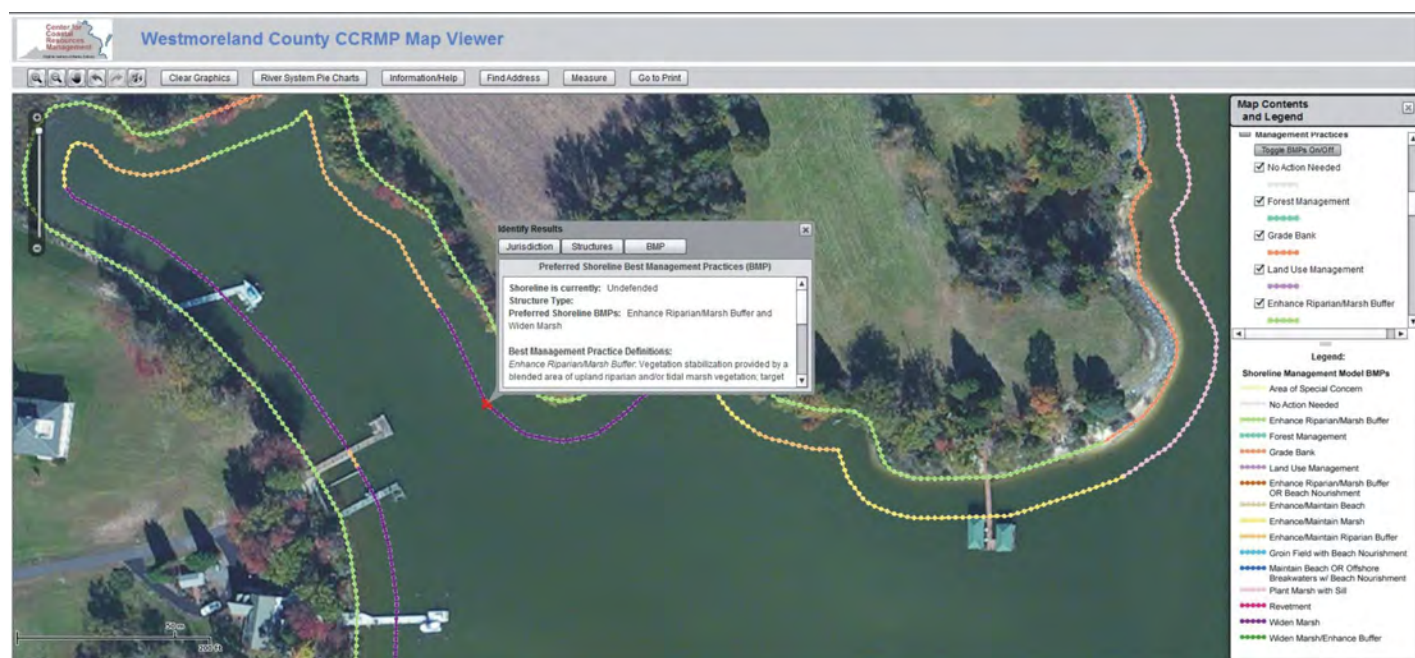
Figure 5-3. The pop-up window contains information about the recommended Shoreline BMP at the site selected. Additional information about the condition of the shoreline is also given.

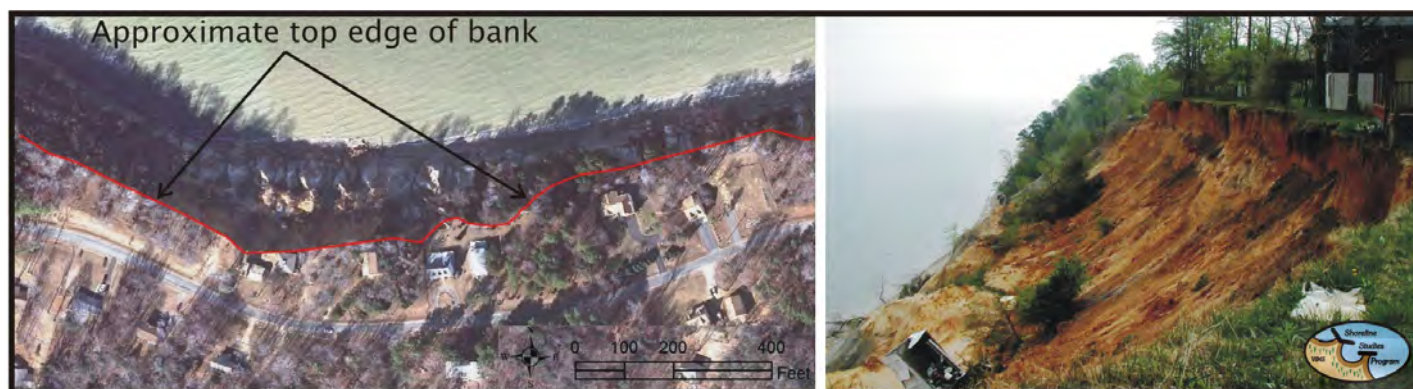
Figure 5-4. The proximity of the top of eroding bank to houses is shown at Stratford Harbour.

Stratford Harbour is a residential development that extends approximately 2 miles alongshore and is situated along Nomini Cliffs. Nomini Cliffs range from 100 to 150 feet high along the upriver section, taper to 40 feet high, and then to low banks just west of Haulover Inlet. The Stratford Harbour shore generally faces north with fetch exposures to the northwest, north, and northeast of eighteen, six, and seven miles, respectively. This is a high wave energy coast. The bluffs are vertically exposed and actively eroding similar to the Horsehead and Stratford Cliffs upriver. However, at Stratford Harbour, numerous houses are only a few yards from the top of the eroding bluff face, and therefore grading the bank to reduce the steepness is not an option (Figure 5-4).

The process of bluff erosion along Stratford Harbour first begins at the base or toe of the bank where persistent impinging wave action erodes the bluff foundation rendering it inherently unstable. Contributing factors include upland runoff, groundwater seeps and springs, and freeze/thaw weathering processes. However, without controlling the erosion at the base of the bank, no bluff stabilization method will succeed over the long term. Historic erosion occurs at about 0.5 ft/yr only because the large volume of eroded material takes time to transport and for a time the slumps protect the base of the in situ bank until the process begins again.

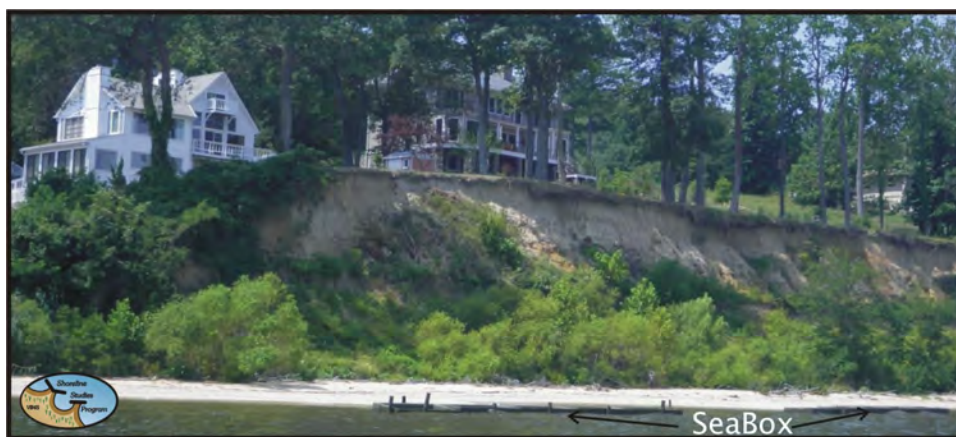
Figure 5-5. Exposed, eroding bank just east of Nomini Cliffs. The Seaboxes have held the bank slump material and allowed it to become vegetated increasing the stability of the bank.

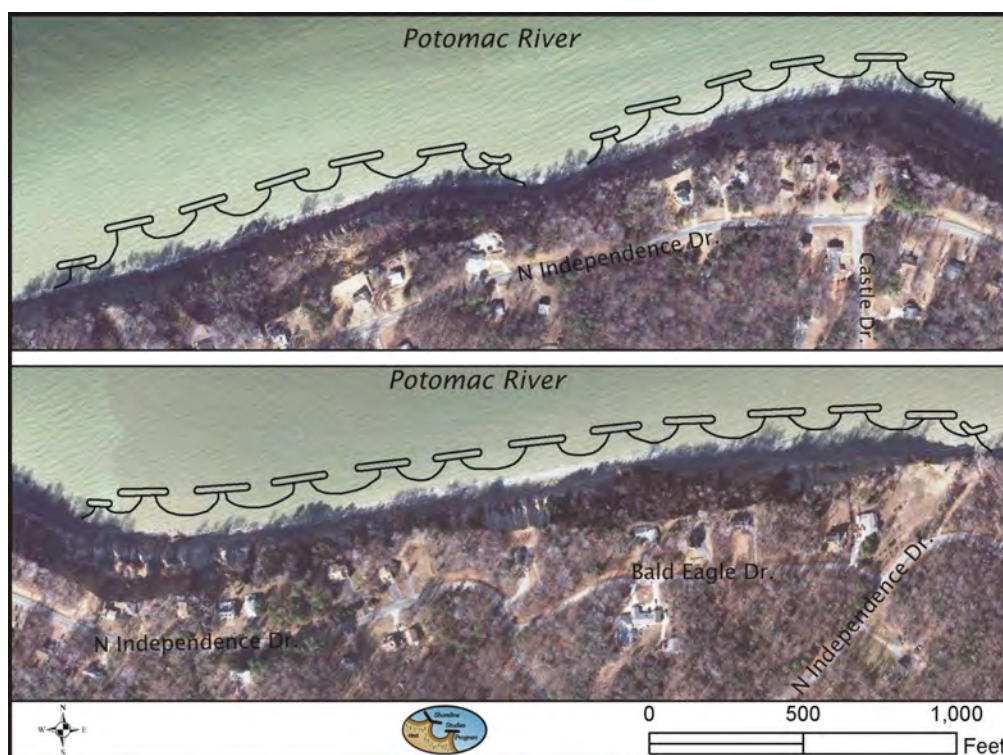
Figure 5-6. Site-specific application of the Shoreline Management Model recommendation for Stratford Harbour. The breakwater system will stabilize the base of the bank, but the strategy does not address top of cliff erosion.

A breakwater system should have a minimum crest length 150 feet with narrow gaps of no more than 100 feet. Calculating the beach indentation to gap ratio results in a line of structures about 130 feet offshore. However, near-shore water depths 150 feet offshore are about -3 feet MLW. One problem with building the system is

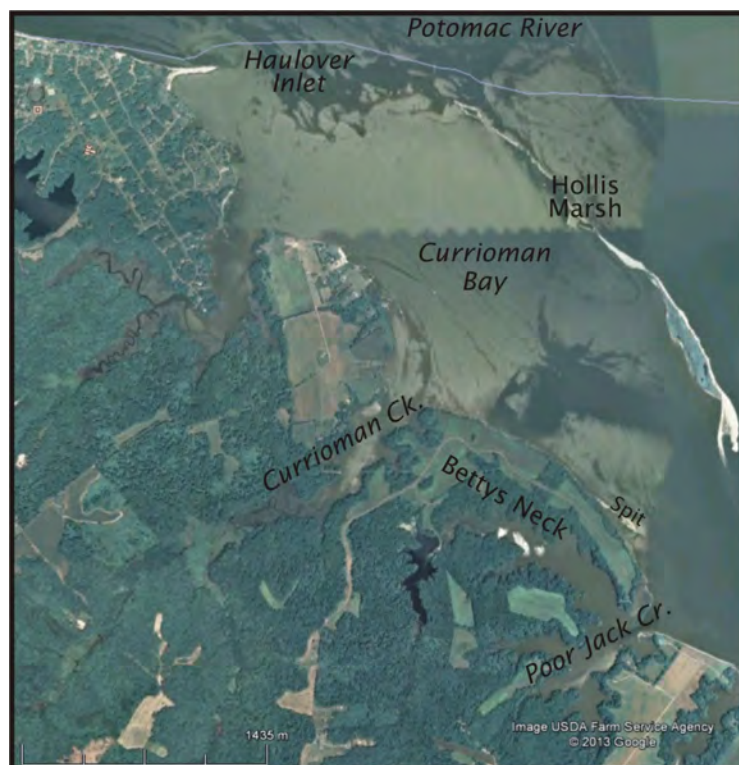
Figure 5-7. Google Earth image showing the location of Betty's Neck.

The distal end of Betty's Neck lies on Curriomon Bay (Figure 5-7) and can be used as an example of a proactive shoreline management plan for an as yet, undeveloped property. From aerial imagery, roads and cul-du-sacs can be seen along the upland that, prior to 2005, were once farmland but is now poised for development. This section will illustrate how a breakwater and sill system can be included in the pre-development plan to create a vegetated edge instead of a hardened shoreline. In addition to stabilizing the shoreline, this plan also may increase value by creating a beach access for landowners.

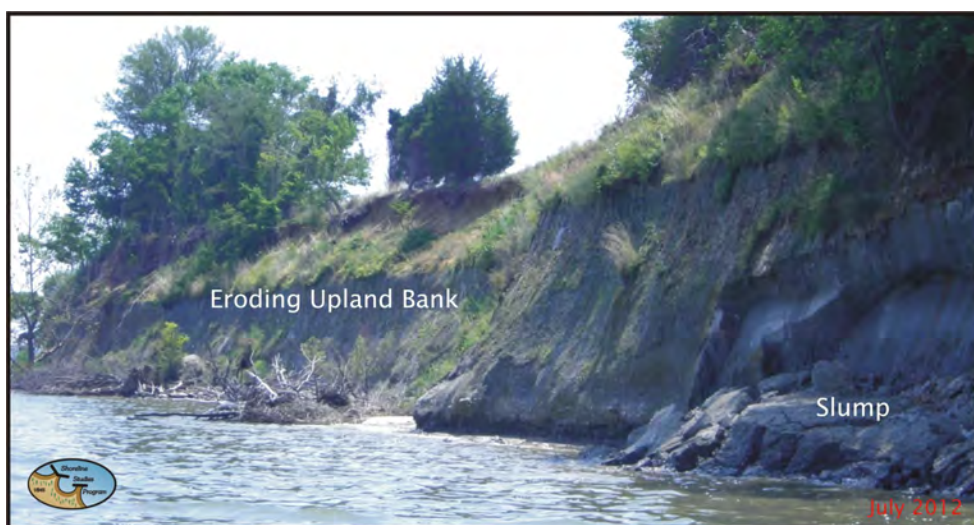
Figure 5-8. Eroding banks along the property ready for development along Betty's Neck.

The shoreline adjacent to Curriomon Creek occurs as fringing marsh that gives way to an actively eroding upland bank about 20 feet in height (Figure 5-8) for about 3,500 feet to the spit. End point
